**Flood Control Project Maintenance
Levee Inspections**

Maintenance Issue Types Only, Levee Inspection Report By Mile - Spring 2018

Reclamation District No. 2089 Stark

Waterway	Bank	Unit Miles	Inspection Start/End	Inspector
Unit No. 01 Old River	Right	1.51	05/15/2018 05/15/2018	Zach Jojola

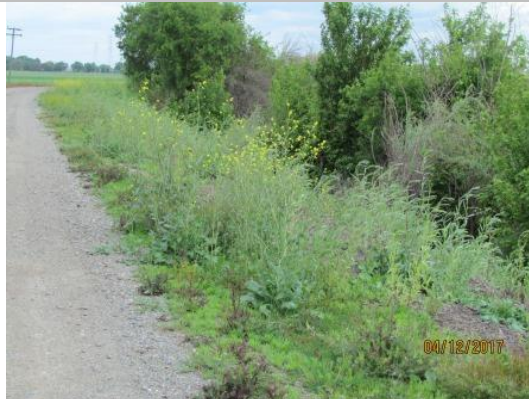
Photo 1 of 2 : SP_2018_RD2089_316_21_20180507_00022.jpg

LM Start	0.82	Rating **	M	Issue No.	21
LM End	0.94	Issue Type +	Ma	Location *	WS
Category	Earthen Levee			GPS Latitude/Longitude	
				Start	End
Item	Vegetation			37.808043 °	37.806442 °
				-121.397853 °	-121.397747 °
DWR ID	DWR_RD2089_01_f_2016_21				
Comment Code					
V2 : Remove the wild growth other than native grasses from the levee slopes.					
Inspector Comment					
Willows starting to encroach onto levee crown.

The willows are starting to creep up the levee slope.

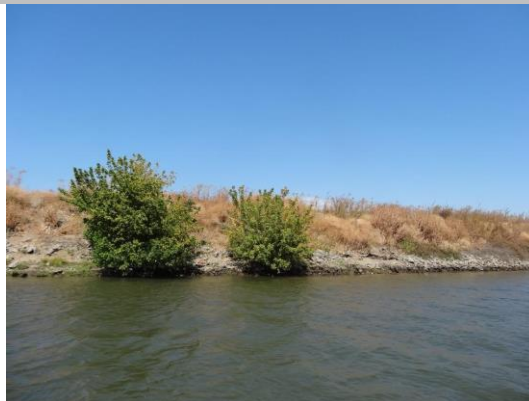
Photo 1 of 3 : SP_2018_RD2089_316_3_20180507_00004.jpg

LM Start	1.17	Rating **	A/W	Issue No.	3 (cont)
LM End	1.17	Issue Type +	Ma	Location *	WS

Front view of the erosion. Note the trees next to the erosion site.

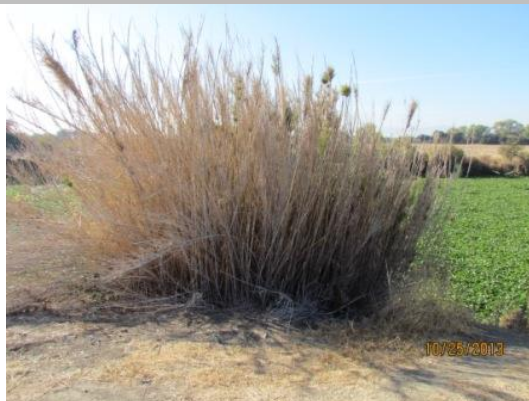
Photo 1 of 1 : SP_2018_RD2089_316_25_20180507_00025.jpg

LM Start	1.19	Rating **	A/W	Issue No.	25
LM End	1.19	Issue Type +	Ma	Location *	WS
Category	Earthen Levee			GPS Latitude/Longitude	
				Start	End
Item	Vegetation			37.805663 °	37.805663 °
				-121.402151 °	-121.402151 °
DWR ID	DWR_RD2089_01_s_2016_25				
Comment Code					
V2 : Remove the wild growth other than native grasses from the levee slopes.					
Inspector Comment					
Arrundo was trimmed back but may creep up the waterside levee slope if not maintained.

View of the Arundo on the waterside slope obstructing visibility. LMA is actively trying to remove the wild growth.

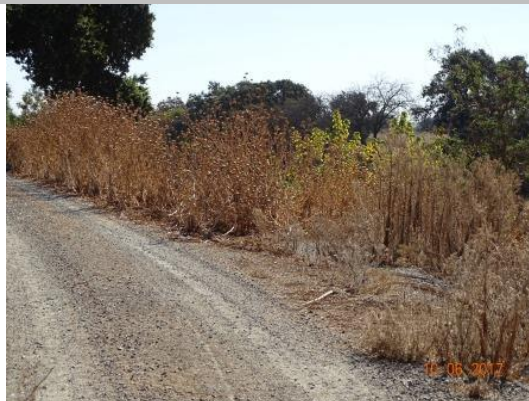
Photo 1 of 1 : SP_2018_RD2089_316_31_20180507_00034.jpg

LM Start	1.19	Rating **	M	Issue No.	31
LM End	1.50	Issue Type +	Ma	Location *	WS
Category	Earthen Levee			GPS Latitude/Longitude	
				Start	End
Item	Vegetation			37.805681 °	37.806602 °
				-121.402202 °	-121.407781 °
DWR ID	DWR_RD2089_01_s_2017_31				
Comment Code					
V2 : Remove the wild growth other than native grasses from the levee slopes.					
Inspector Comment					
Remove thistle from the levee slope.

View of the tall vegetation on the levee slope.

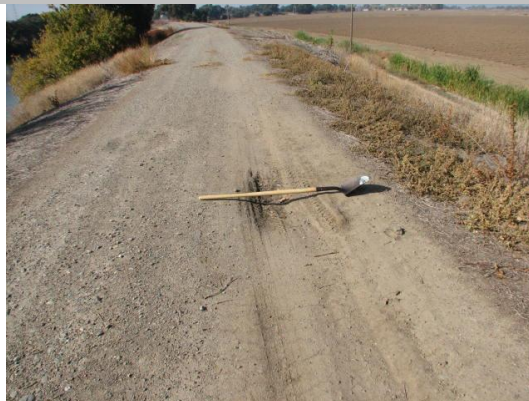
Photo 1 of 1 : SP_2018_RD2089_316_44_20180507_00038.jpg

LM Start	1.23	Rating **	M	Issue No.	44
LM End	1.23	Issue Type +	Ma	Location *	LS
Category	Earthen Levee			GPS Latitude/Longitude	
				Start	End
Item	Crown Surface / Depressions / Rutting			37.805801 °	37.805801 °
				-121.402913 °	-121.402913 °
DWR ID	DWR_RD2089_01_s_2012_44				
Comment Code					
C3 : Add appropriate gravel or road base. Grade and compact.					
Inspector Comment					
11/10/2011 Depression in roadway needs to be filled.

11/10/2011 Roadway depression.

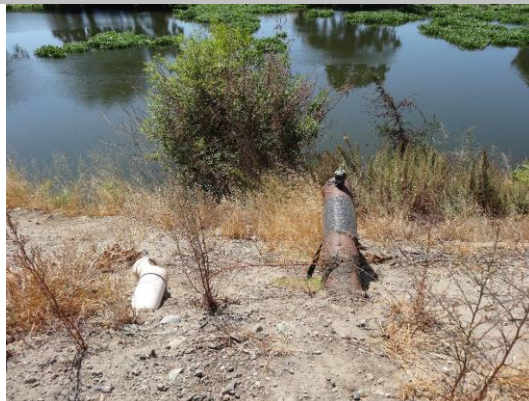
Photo 1 of 3 : UCIP_SP_2018_21585_36624.jpg

LM Start	1.41	Rating **	M	Issue No.	961
LM End	1.41	Issue Type +	Ma	Location *	
Category	Supplemental			GPS Latitude/Longitude	
				Start	End
Item	DWR UCIP LMA Responsibility			37.806323 °	37.806323 °
				-121.406155 °	-121.406155 °
DWR ID					
Comment Code					
Inspector Comment					
FS_ID:21585 DS_ID:23045 EP_NO: N/A Repair Type: Non-Urgent Crossing Status: Found UCIP Comments: - siphon breaker needs repair. FIELD_STRUCT_DESC: 10-inch steel drainage discharge pipe through the levee, 2.4 feet below the crown. Pump in a drainage ditch on the landside (LS). Siphon breaker on the waterside (WS) shoulder. [Additional Reference(s): DWR Levee Log, 1991]. FS Date: 9/12/2013

WS view: exposed steel pipe on levee slope. A pvc pipe on left.

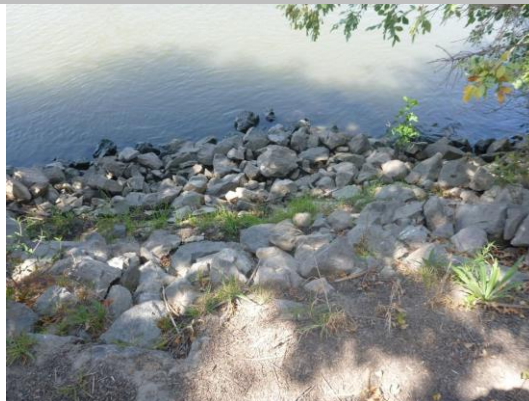
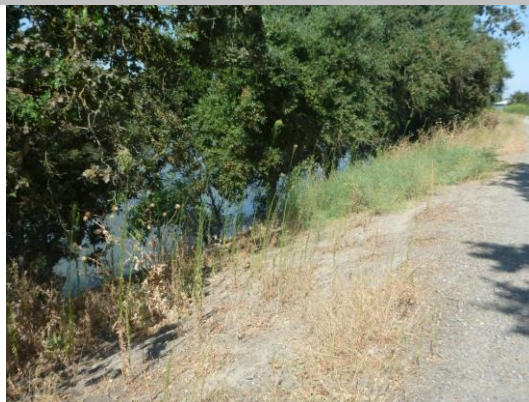
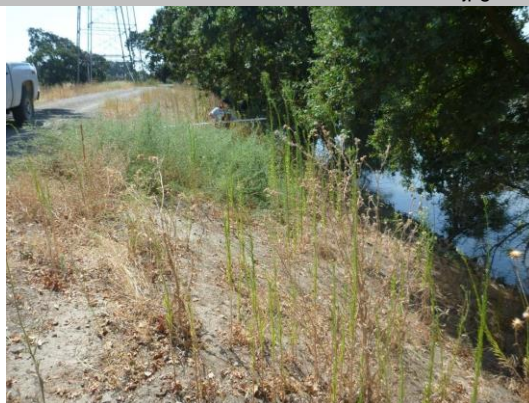
LM Start	0.20	Rating **	M	Issue No.	46
LM End	0.21	Issue Type +	Ma	Location *	
Category	Supplemental			GPS Latitude/Longitude	
				Start	End
Item	2017 Storm Damage			37.809100 °	37.809200 °
				-121.409800 °	-121.409900 °
DWR ID	DWR_RD2089_02_f_2017_46				
Comment Code					
Inspector Comment					
Levee Evaluation Comments					
Description:Slope protection repairs are needed along the waterside slope due to erosion and riprap displacement from high water. Based upon levee inspections, it was determined the waterside levee slope is eroding, deteriorating, and degrading. The eroded levee sections need to be restored back to design standards to prevent further deterioration and damage.					
Site ID No:509					
Site Designation:LMA-415					
Repair Type: Erosion					
Rating:Area of Concern					
Field Date:8/16/2017					
Notes: Displaced riprap at toe.

LM Start	0.20	Rating **	M	Issue No.	46 (cont)
LM End	0.21	Issue Type +	Ma	Location *	
Category	Supplemental			GPS Latitude/Longitude	
				Start	End
Item	2017 Storm Damage			37.809100 °	37.809200 °
				-121.409800 °	-121.409900 °
DWR ID	DWR_RD2089_02_f_2017_46				
Comment Code					
Inspector Comment					
Levee Evaluation Comments					
Description:Slope protection repairs are needed along the waterside slope due to erosion and riprap displacement from high water. Based upon levee inspections, it was determined the waterside levee slope is eroding, deteriorating, and degrading. The eroded levee sections need to be restored back to design standards to prevent further deterioration and damage.					
Site ID No:509					
Site Designation:LMA-415					
Repair Type: Erosion					
Rating:Area of Concern					
Field Date:8/16/2017					
Notes: Displaced riprap at toe.

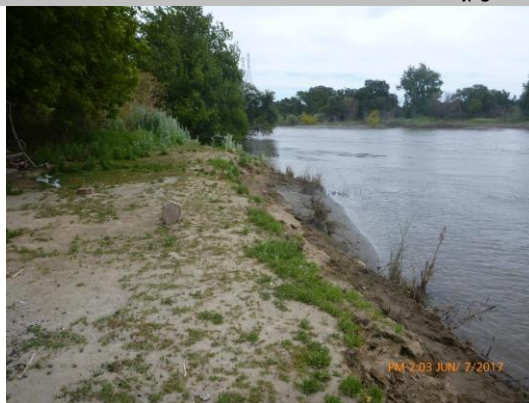
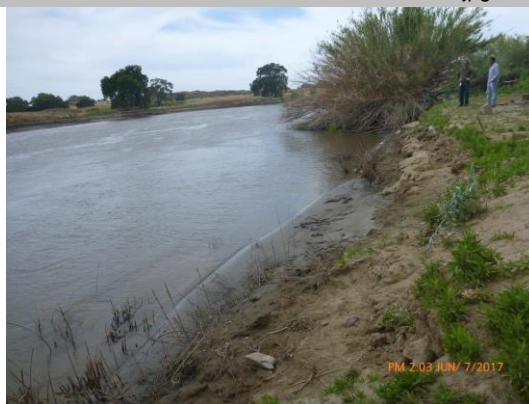
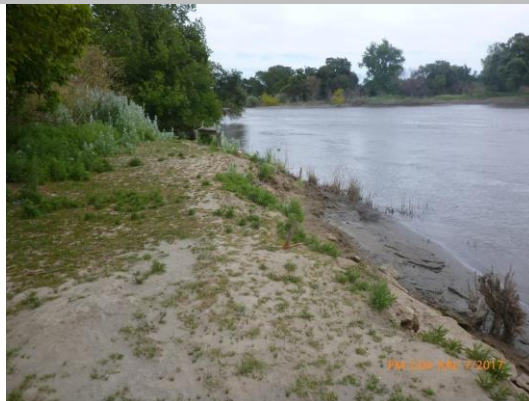
LM Start	0.32	Rating **	A/W	Issue No.	47
LM End	0.57	Issue Type +	Ma	Location *	
Category	Supplemental			GPS Latitude/Longitude	
				Start	End
Item	2017 Storm Damage			37.810020 °	37.811810 °
				-121.411550 °	-121.415390 °
DWR ID	DWR_RD2089_02_f_2017_47				
Comment Code					
Inspector Comment					
Levee Evaluation Comments					
Description:					
Site ID No:109					
Site Designation:335-103					
Repair Type: Erosion					
Rating:Area of Concern					
Field Date:6/7/2017					
Notes: vegetation too dense for evaluation

LM Start	0.32	Rating **	A/W	Issue No.	47 (cont)	
LM End	0.57	Issue Type +	Ma	Location *		
Category	Supplemental			GPS Latitude/Longitude		
				Start		End
Item	2017 Storm Damage			37.810020	°	37.811810
				-121.411550	°	-121.415390
DWR ID	DWR_RD2089_02_f_2017_47					
Comment Code						
Inspector Comment						
Levee Evaluation Comments						
Description:						
Site ID No:109						
Site Designation:335-103						
Repair Type: Erosion						
Rating:Area of Concern						
Field Date:6/7/2017						
Notes: vegetation too dense for evaluation

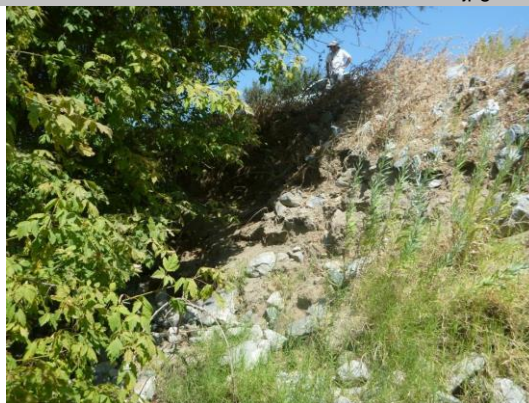
Photo 3 of 3 : LEVAL_SP_2018_508_4325.jpg

LM Start	0.39	Rating **	A/W	Issue No.	50 (cont)	
LM End	0.41	Issue Type +	Ma	Location *		
Category	Supplemental			GPS Latitude/Longitude		
				Start		End
Item	2017 Storm Damage			37.810150 °		37.810270 °
				-121.412930 °		-121.413240 °
DWR ID	DWR_RD2089_02_f _ 2017_50

Comment Code						
Inspector Comment						
Levee Evaluation Comments						
Description:Slope protection repairs are needed along the waterside slope due to erosion and riprap displacement from high water. Based upon levee inspections, it was determined the waterside levee slope is eroding, deteriorating, and degrading. The eroded levee sections need to be restored back to design standards to prevent further deterioration and damage.						
Site ID No:508						
Site Designation:LMA-414						
Repair Type: Erosion						
Rating:Serious						
Field Date:8/16/2017						
Notes: Large erosion around tree with a 12' vertical cut.

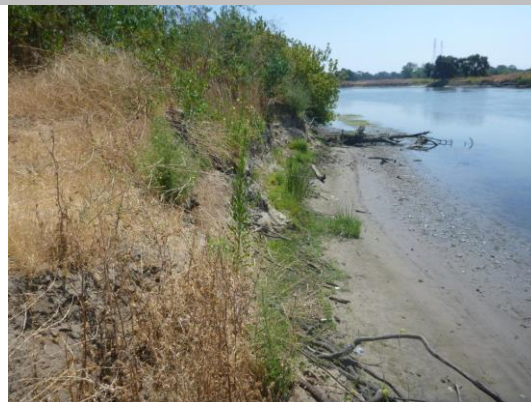
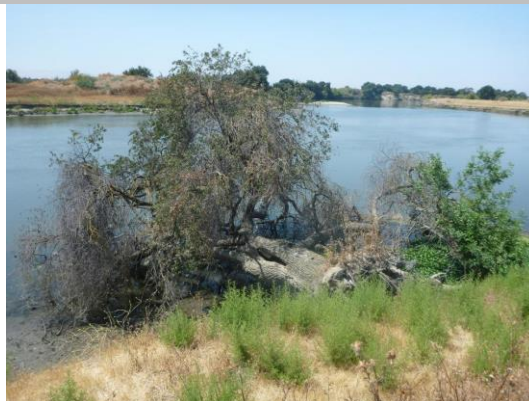
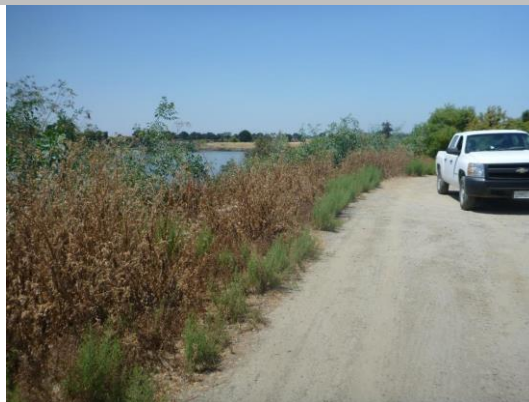
LM Start	0.60	Rating **	A/W	Issue No.	56
LM End	0.61	Issue Type +	Ma	Location *	
Category	Supplemental			GPS Latitude/Longitude	
				Start	End
Item	2017 Storm Damage			37.812000 °	37.812100 °
				-121.415700 °	-121.415900 °
DWR ID	DWR_RD2089_02_s_2018_56				
Comment Code					
Inspector Comment					
Levee Evaluation Comments					
Description:Slope protection repairs are needed along the waterside slope due to erosion and riprap displacement from high water. Based upon levee inspections, it was determined the waterside levee slope is eroding, deteriorating, and degrading. The eroded levee sections need to be restored back to design standards to prevent further deterioration and damage.					
Site ID No:507					
Site Designation:LMA-413					
Repair Type: Erosion					
Rating:Serious					
Field Date:8/16/2017					
Notes: Vertical cut on outside bend of river

LM Start	0.60	Rating **	A/W	Issue No.	56 (cont)	
LM End	0.61	Issue Type +	Ma	Location *		
Category	Supplemental			GPS Latitude/Longitude		
				Start		End
Item	2017 Storm Damage			37.812000 °		37.812100 °
				-121.415700 °		-121.415900 °
DWR ID	DWR_RD2089_02_s _ 2018_56					
Comment Code						
Inspector Comment						
Levee Evaluation Comments						
Description:Slope protection repairs are needed along the waterside slope due to erosion and riprap displacement from high water. Based upon levee inspections, it was determined the waterside levee slope is eroding, deteriorating, and degrading. The eroded levee sections need to be restored back to design standards to prevent further deterioration and damage.						
Site ID No:507						
Site Designation:LMA-413						
Repair Type: Erosion						
Rating:Serious						
Field Date:8/16/2017						
Notes: Vertical cut on outside bend of river

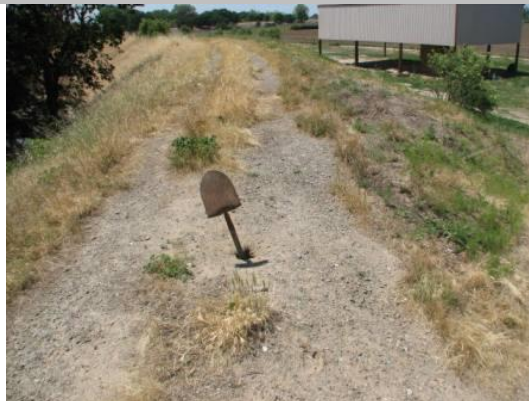
Photo 2 of 3 : SP_2018_RD2089_317_40_20180507_00040.jpg

LM Start	0.85	Rating **	U	Issue No.	40 (cont)	
LM End	0.90	Issue Type +	Ma	Location *	LS	
Category	Earthen Levee			GPS Latitude/Longitude		
				Start		End
Item	Animal Control			37.814997 °		37.814970 °
				-121.414774 °		-121.415767 °
DWR ID	DWR_RD2089_02_s_2012_40					
Comment Code						
A1 : Exterminate rodents and backfill and compact or grout burrows.						
Inspector Comment						
Numerous burrows on landside slope adjacent to hay storage area. Deep burrows in crown and landside ramp.

05/24/2011 Deep vertical burrow in levee crown.

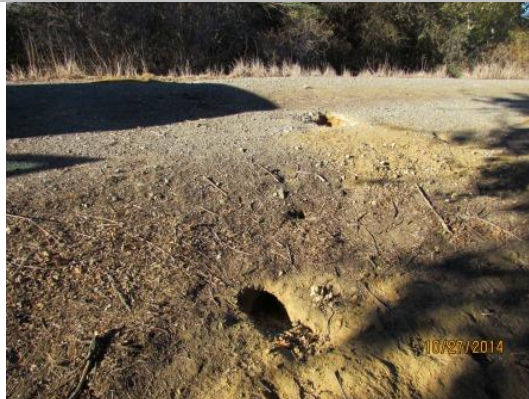
Photo 2 of 2 : SP_2018_RD2089_317_12_20180507_00014.jpg

LM Start	1.00	Rating **	U	Issue No.	12 (cont)	
LM End	1.00	Issue Type +	Ma	Location *	CR	
Category	Earthen Levee			GPS Latitude/Longitude		
				Start		End
Item	Animal Control			37.815182 °		37.815182 °
				-121.417439 °		-121.417439 °
DWR ID	DWR_RD2089_02_f_2014_12					
Comment Code						
A3 : No rodents visible, but rodent burrows visible; need to backfill and compact or grout burrows.						
Inspector Comment

View of several rodent burrows on landside levee hinge and crown.
